# GREENING Infrastructure

Concept designs for three sites in Hampden, MA  
By Nate Card & Lion Waxman

# EAST BROOK for a Living Watershed

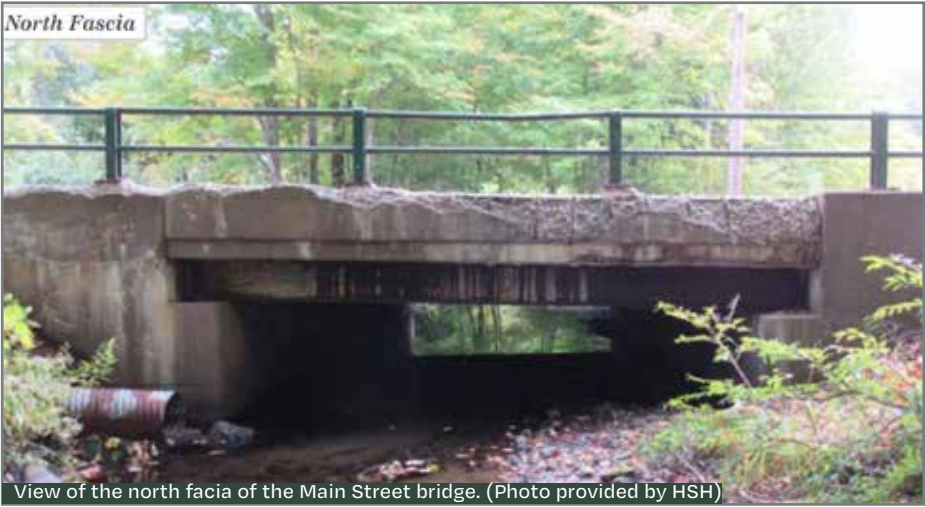
View of the north fascia of the Main Street bridge. (Photo provided by HSH)

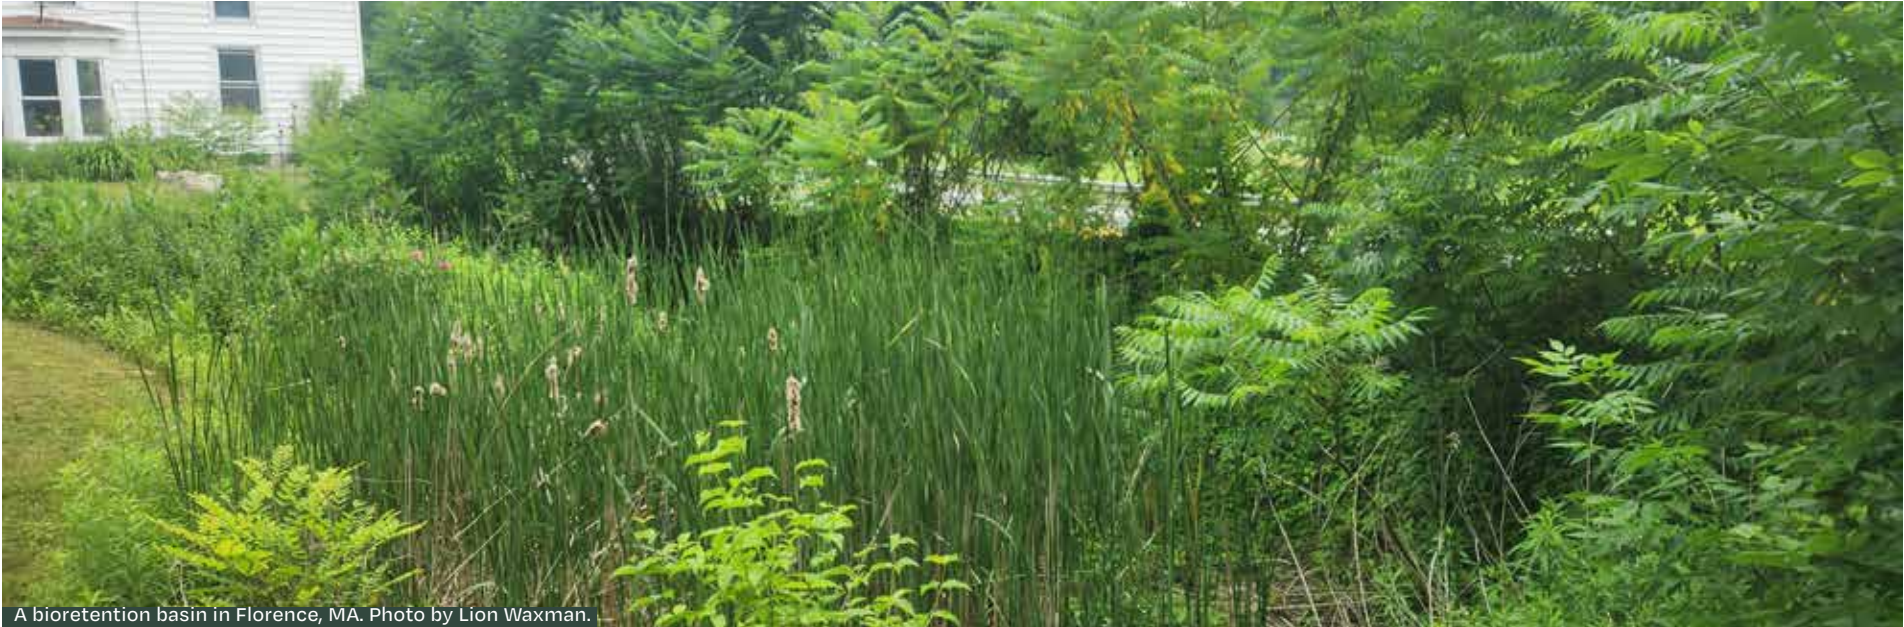
A bioretention basin in Florence, MA. Photo by Lion Waxman.

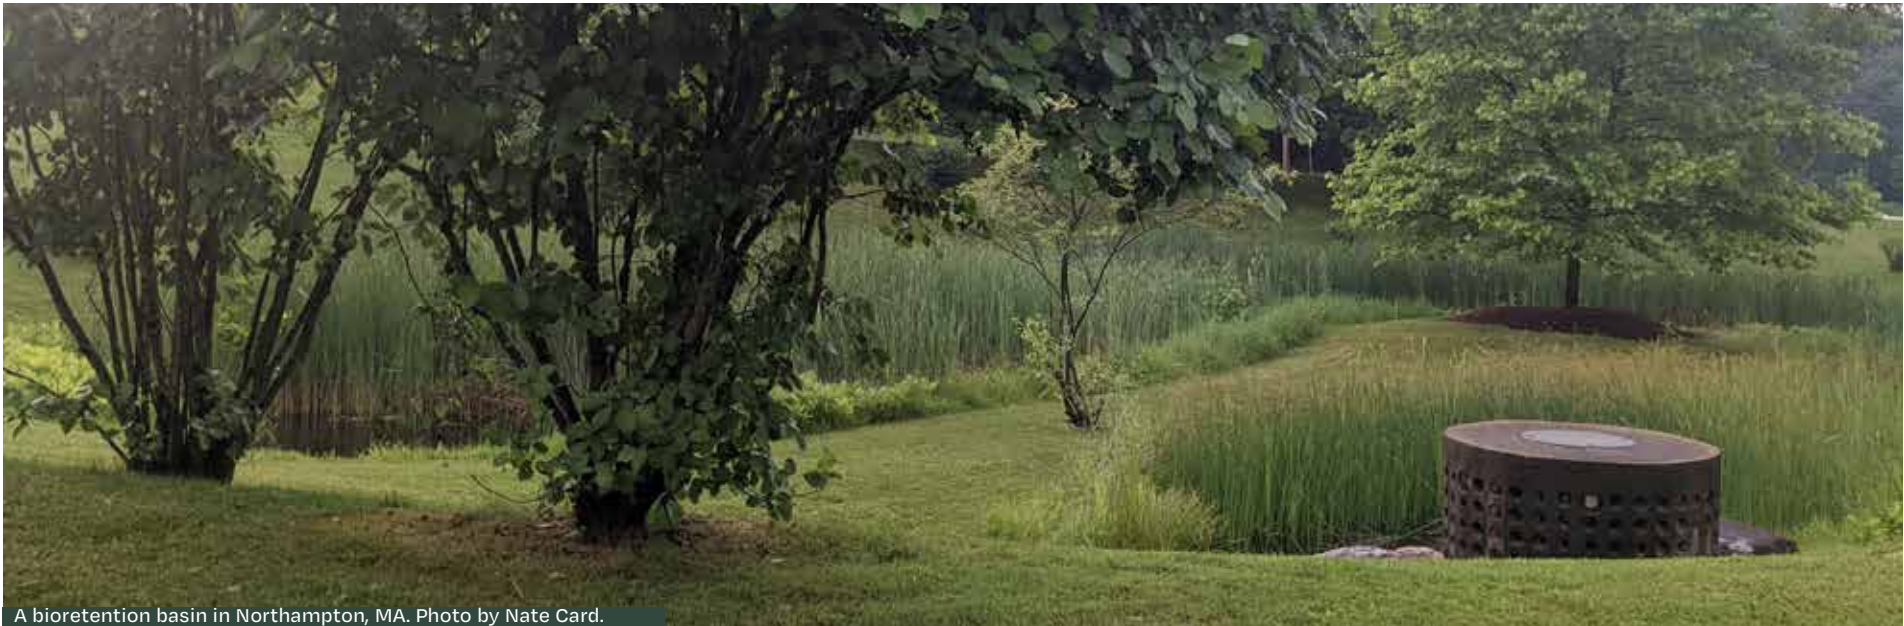
A bioretention basin in Northampton, MA. Photo by Nate Card.

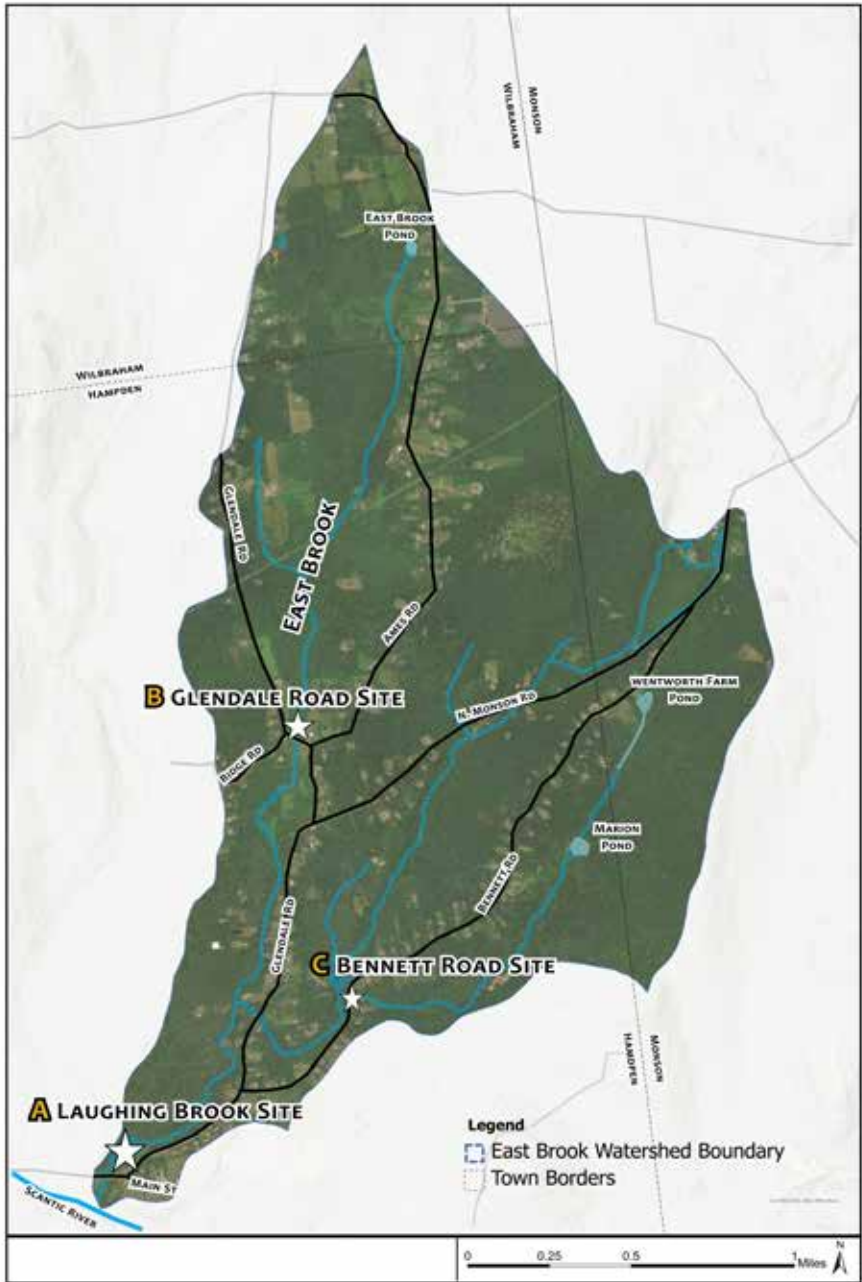
## East Brook Watershed

All project sites sit within the East Brook Watershed, and conditions at these sites are influenced by patterns and conditions occurring at the watershed scale. The East Brook Watershed, which spans portions of three Massachusetts towns—Hampden, Wilbraham, and Monson—sits within the Scantic River Watershed, and is part of the much larger Connecticut River Basin.

East Brook originates at the north edge of the watershed at East Brook Pond, and has multiple unnamed tributaries that join it as it flows south. Site A is located near the lowest point in the watershed; East Brook joins the Scantic River just south of the site. Sites B and C are located upstream. Sites A and B are situated along East Brook. Site C sits on an unnamed tributary of the brook. There are two small ponds upstream along this tributary. Otherwise, there are no dams along East Brook but multiple roads with undersized culverts and bridges can function like dams by constricting water flows during flood events.

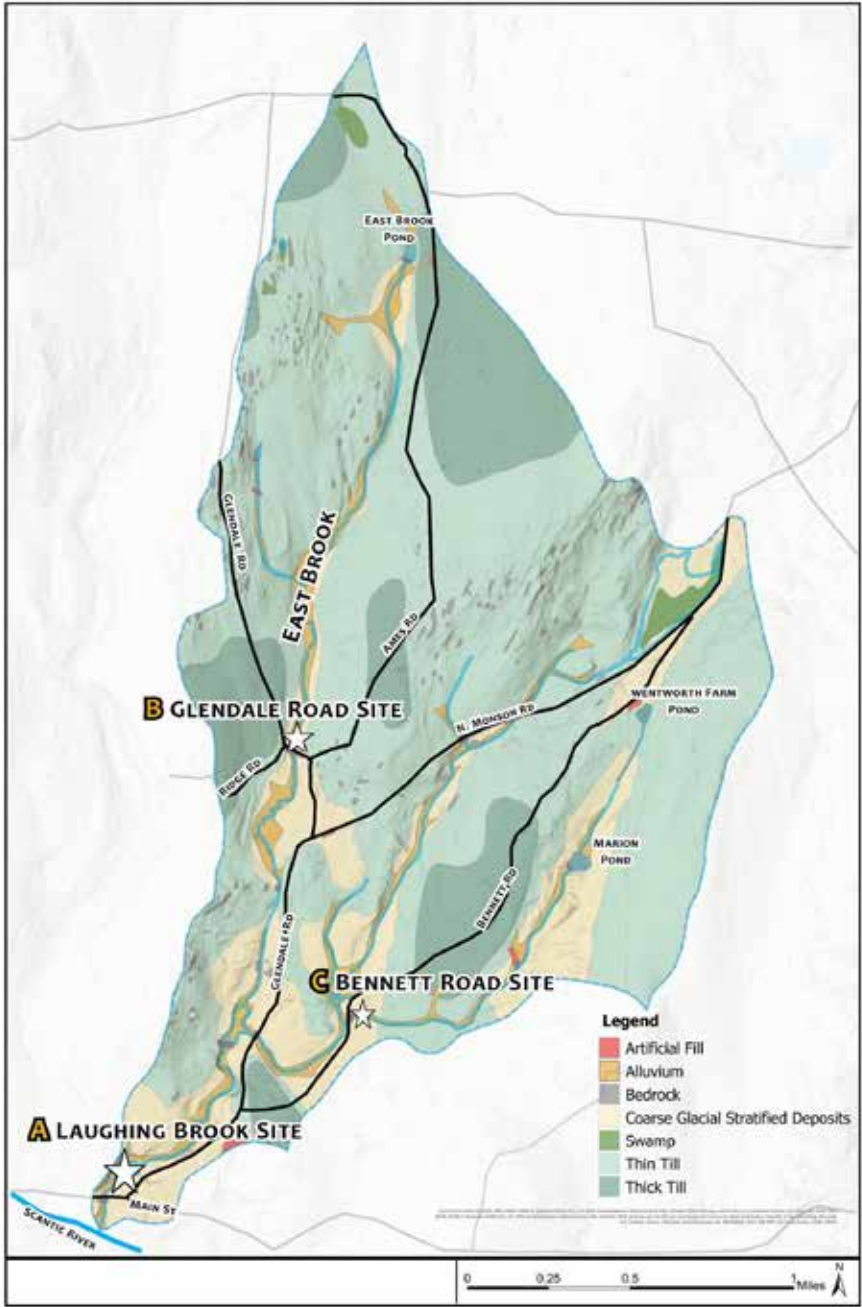
Surficial Geology

As glaciers receded they created different surficial geological deposits in the landscape, affecting how water flows over and through the land. The hills of the watershed are covered in a combination of thick and thin glacial till, while the valleys have coarse glacial stratified deposits. In addition, as water from melting glaciers formed this landscape, it further left behind alluvial deposits, a good parent material for rich soils. These ancient geological flows created by water movement (glaciers and rivers) continue to affect how water flows through the watershed today and are an important factor that may affect site conditions for green infrastructure. While generally located within bands of alluvium, which tends to be well draining, all three sites are actually within or adjacent to artificial fill (being situated along built roads and stream crossing) and thus may have unpredictable drainage conditions.

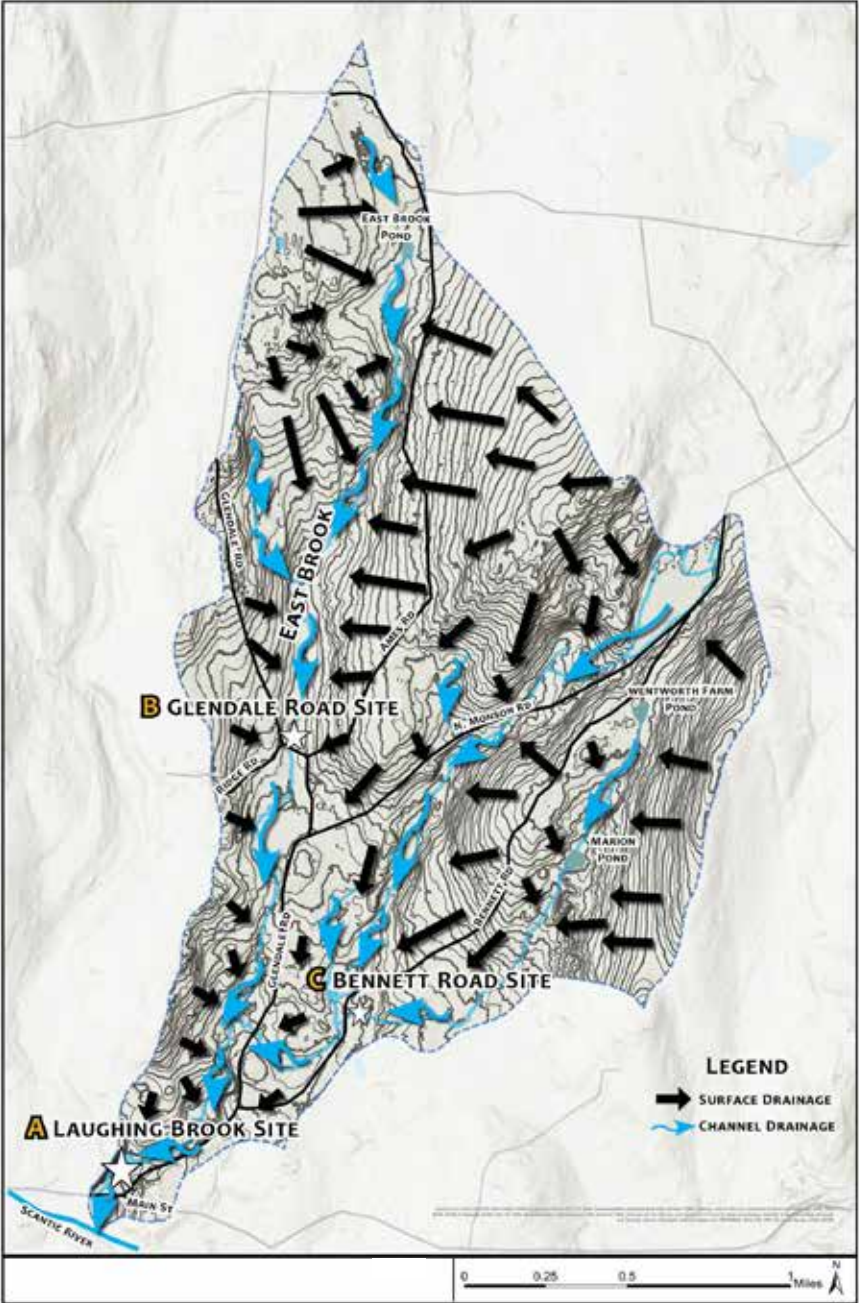
## Drainage

East Brook and its tributaries collect the water that drains off the hills of the watershed. Headwaters for this drainage flow include East Brook Pond at the north edge of Ames Road, a wetland area at the northeast end of North Monson Road and a couple of ponds east of Bennett road. All three project sites sit near or in floodplains where steep slopes meet wider valleys; however, infrastructure like roads, bridges, and culverts at these locations form choke points, constricting water flow where it would otherwise spread out as the valley widens. Site A, Laughing Brook, sits at the mouth of the watershed, and thus has drainage flows coming into it both from the immediate surroundings as well as from the entire watershed, potentially making it more susceptible to flooding.

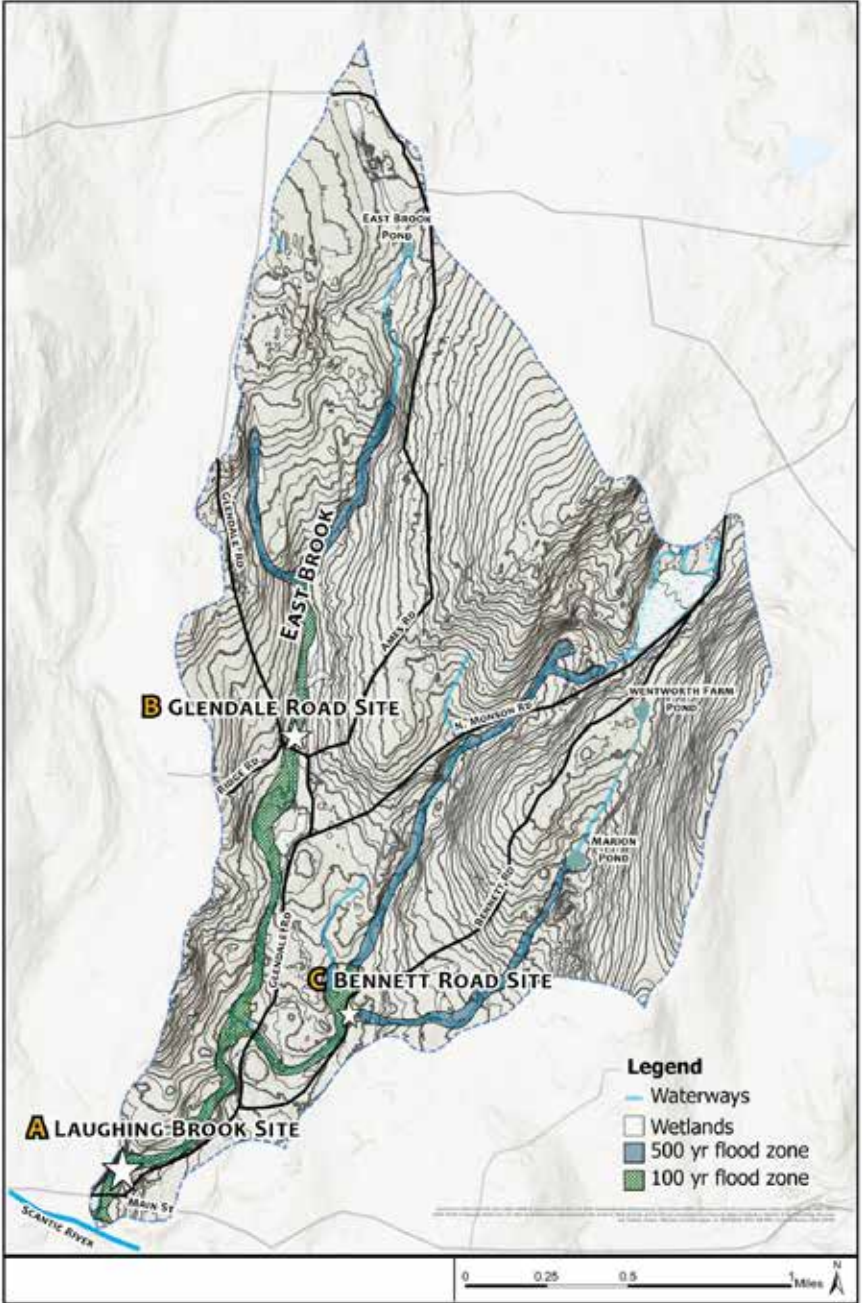
## Floodplains

East Brook and sections of its tributaries are subject to flooding. All three project sites sit partially or completely within the FEMA 100-year flood zone. Although the watershed is heavily forested, and forest cover can slow water flows, the steep slopes of the upper watershed can cause fast flowing runoff, leading to water levels rising quickly and flash flooding patterns. Adding to this issue is the fact that due to climate change, there is an increasing occurrence of heavy precipitation storm events, which may lead to even more flooding, both at the project sites and throughout the watershed.

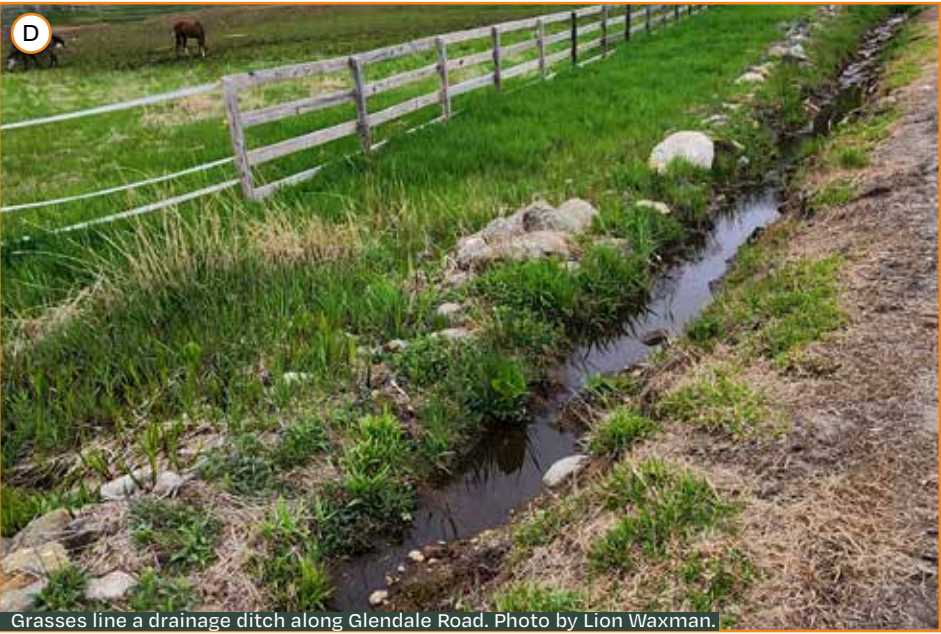
Grasses line a drainage ditch along Glendale Road. Photo by Lion Waxman.

Municipal storm drains collect runoff from the steeply sloped Ames Road to the east, and convey it under the intersection before outletting into the roadside ditch on the north side of Glendale Road. From here there is a narrow drainage ditch conveying this water to a small back-up culvert crossing under the road to the south. This drainage ditch has standing water in it, which may be due to multiple conditions: a high water table; the dam effect of the road; and collection of sediment and silt from the horse paddock due to the road's position in the valley, intercepting runoff which would otherwise filter into the wetland South of Glendale Road.

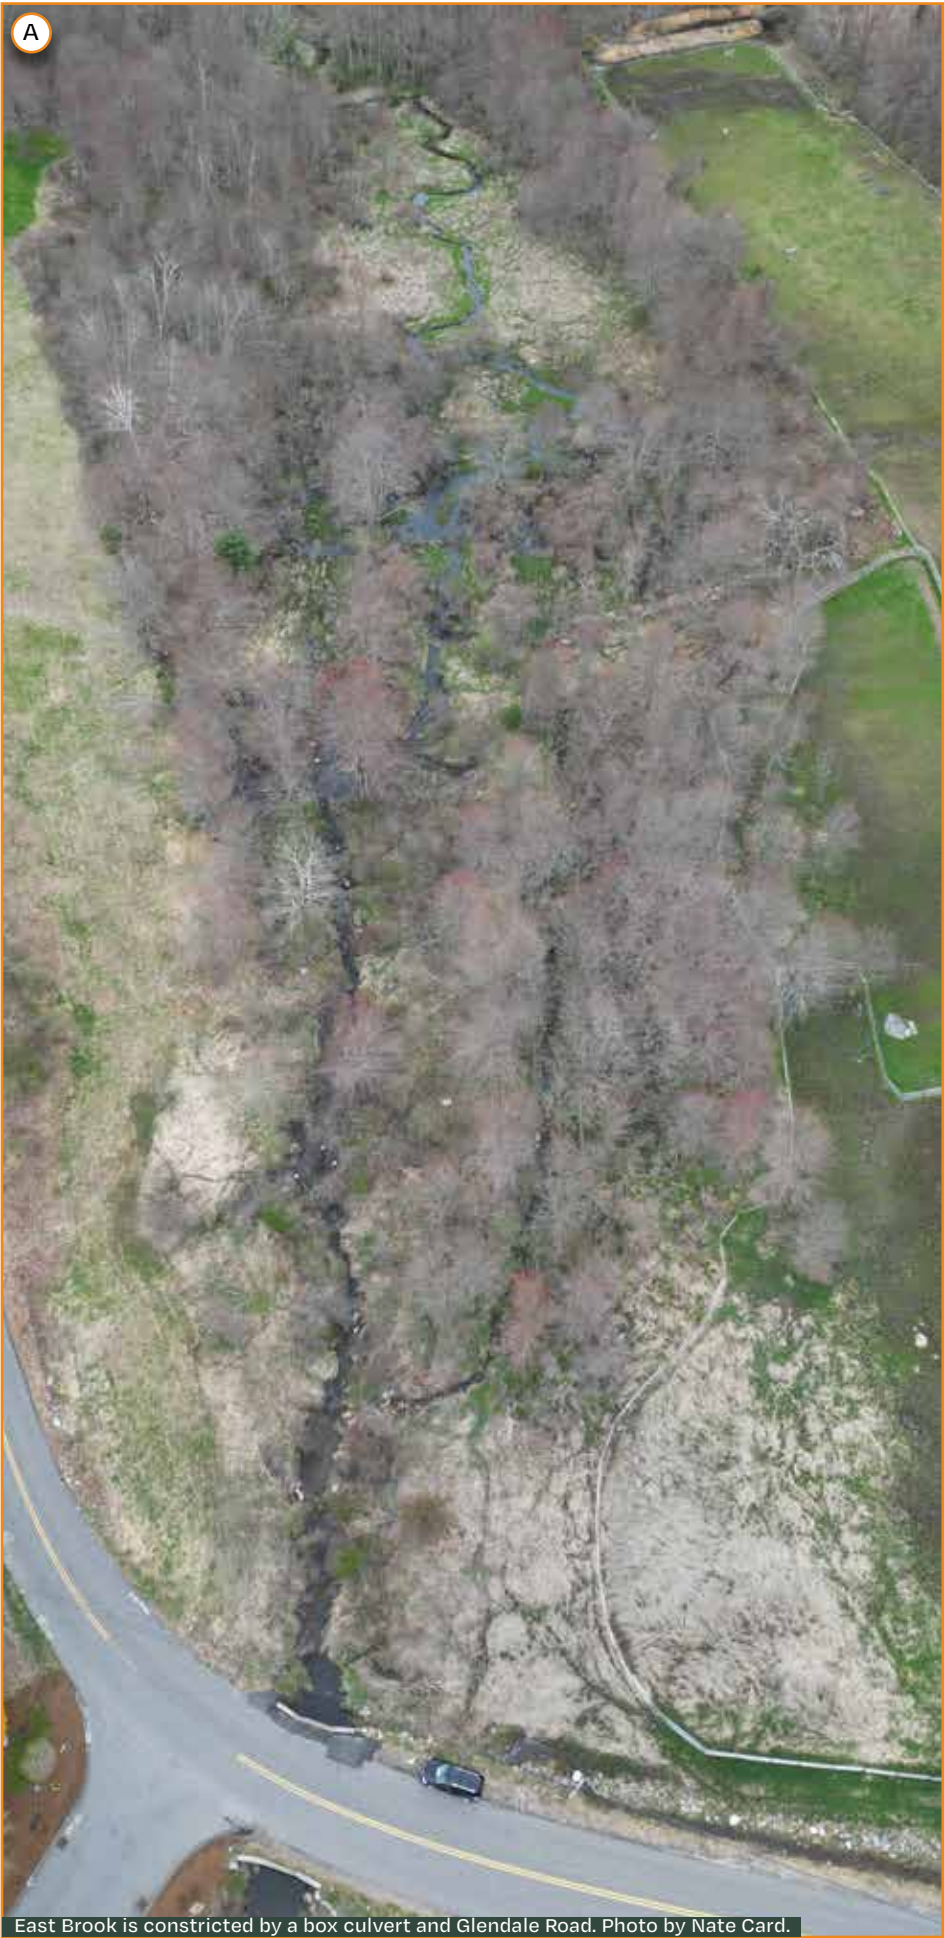
East Brook is constricted by a box culvert and Glendale Road. Photo by Nate Card.

At this project site, Glendale Road spans a floodplain at a place where the landscape flattens and widens from its more narrow and steeply inclined character farther up in the watershed. Effectively, during large storm events Glendale Road and the box culvert function as a dam, and East Brook, which would naturally spread out and meander through this part of the landscape, is constrained to a narrow channel flowing through the aging and undersized box culvert.

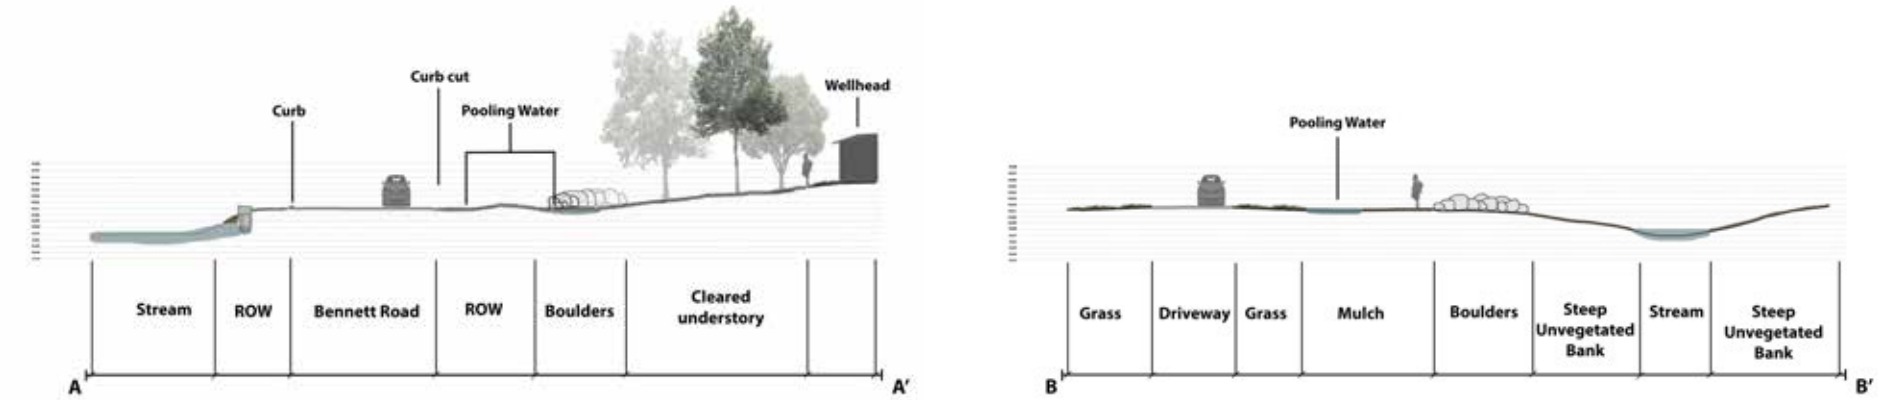
Above: Sections denoting elevations of ground surface and related features, relative to suggested area for green stormwater infrastructure (GSI) adjacent to ROW

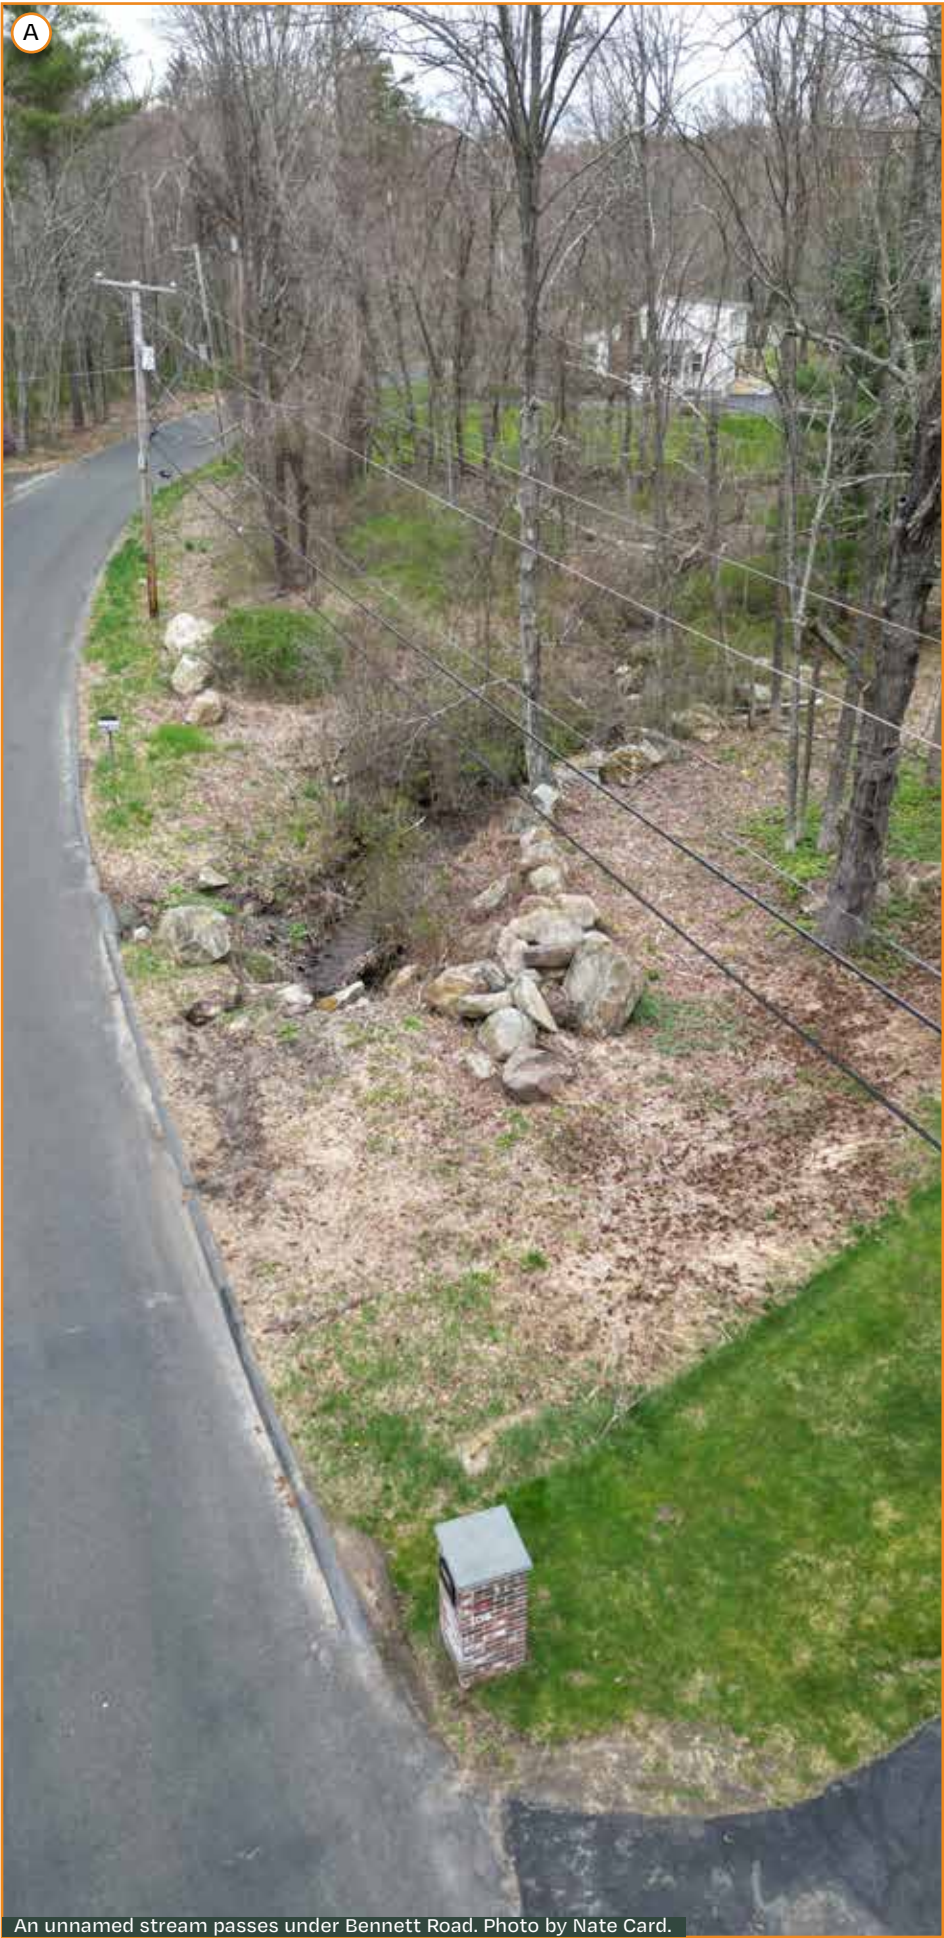
An unnamed stream passes under Bennett Road. Photo by Nate Card.

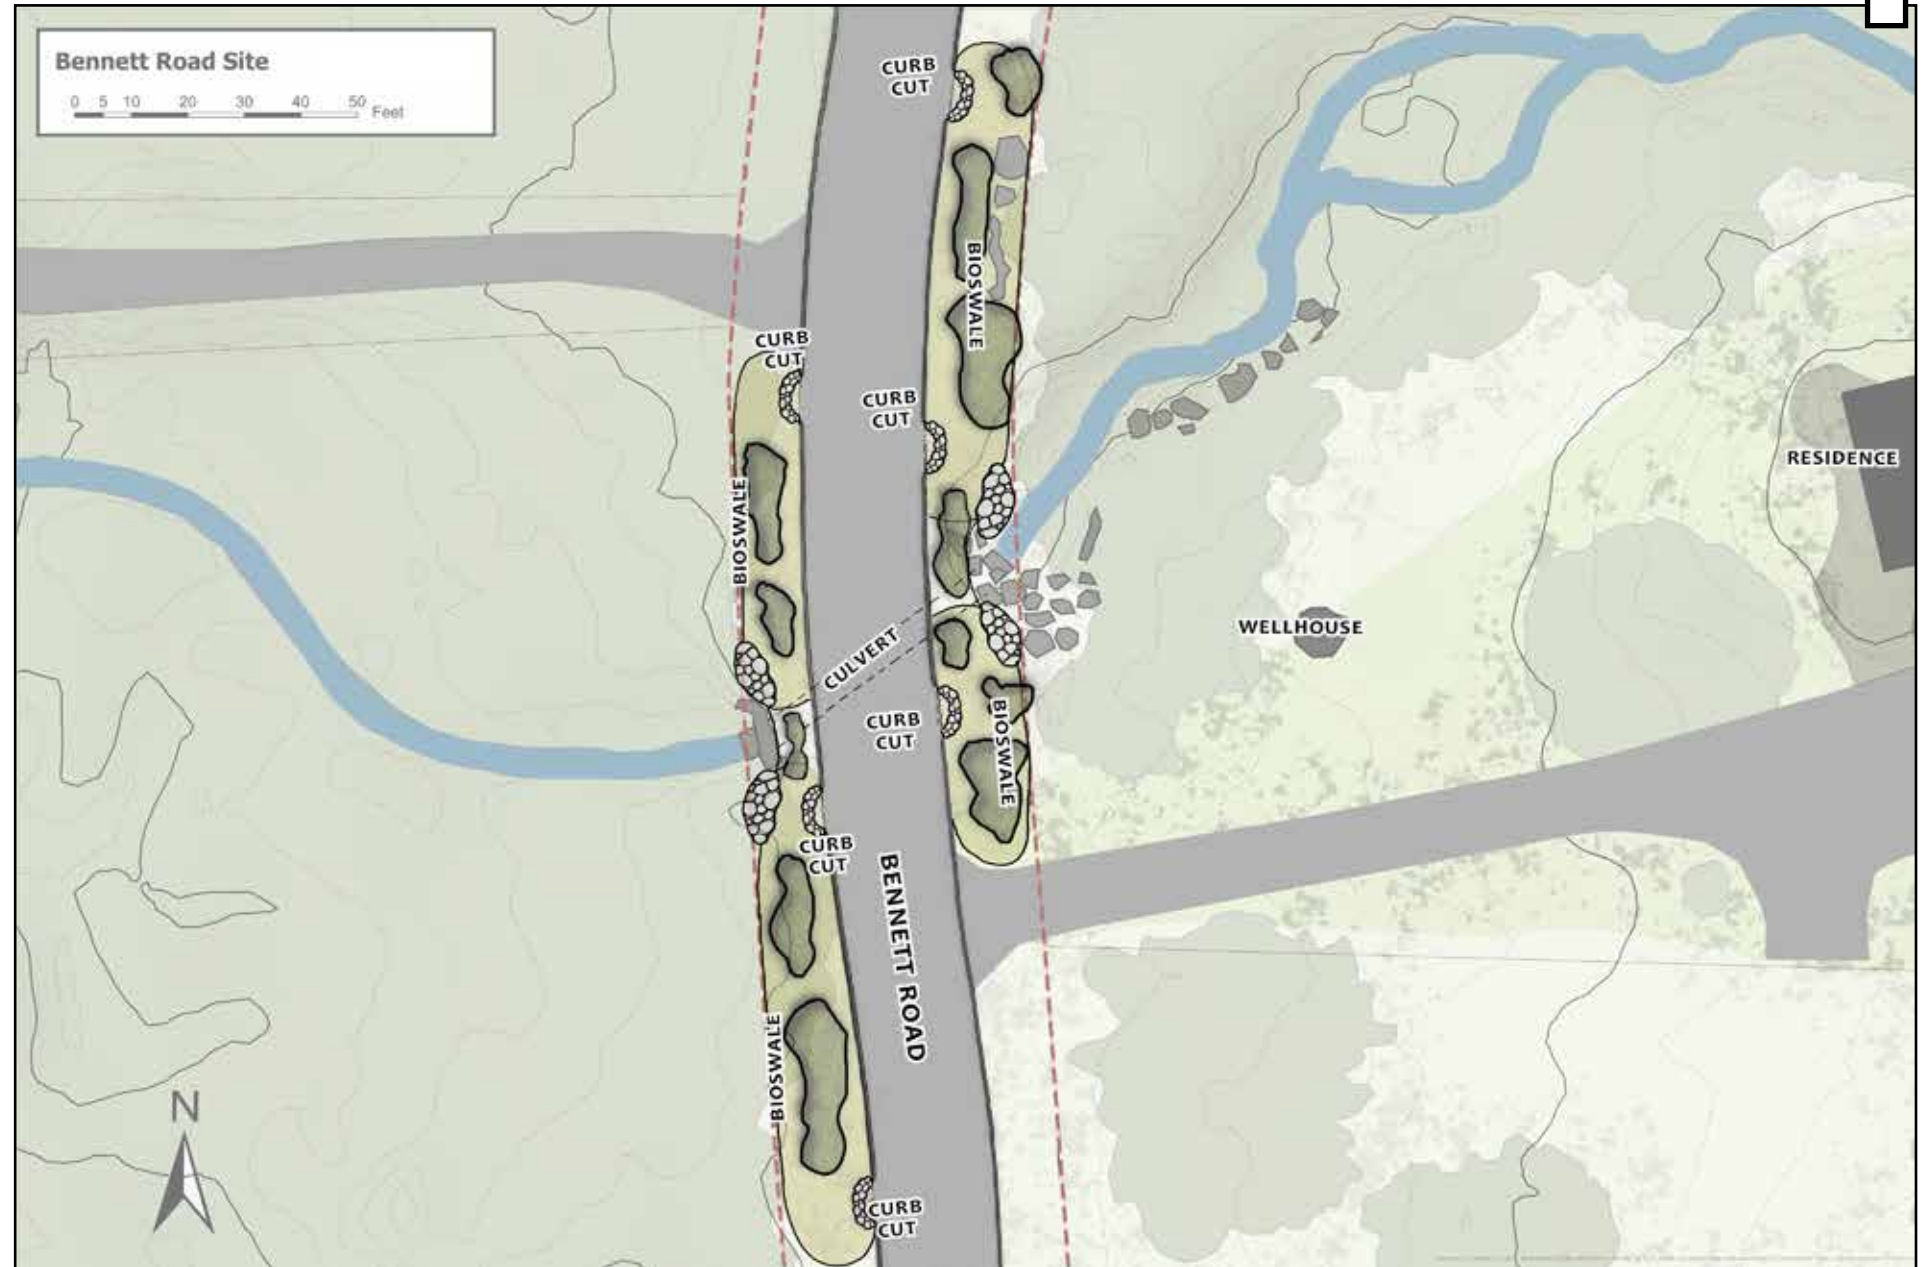
## "Simple Swales"

*Makes the most of available ROW with a series of bioswales, treating runoff before it enters a tributary to East Brook.*

This simple design alternative is limited to the ROW. (1) Vegetated bioswales are graded sufficiently to allow runoff from the road to enter via curb cuts and flow to the stream while being treated by native vegetation. (2) Additional curb cuts further away from the culvert in both directions along Bennett Road divert runoff into the swales before it reaches the low point in the road south of the culvert, mitigating pooling. (3) Additional rock armor is added around the culvert on either side of the road to mitigate erosion.

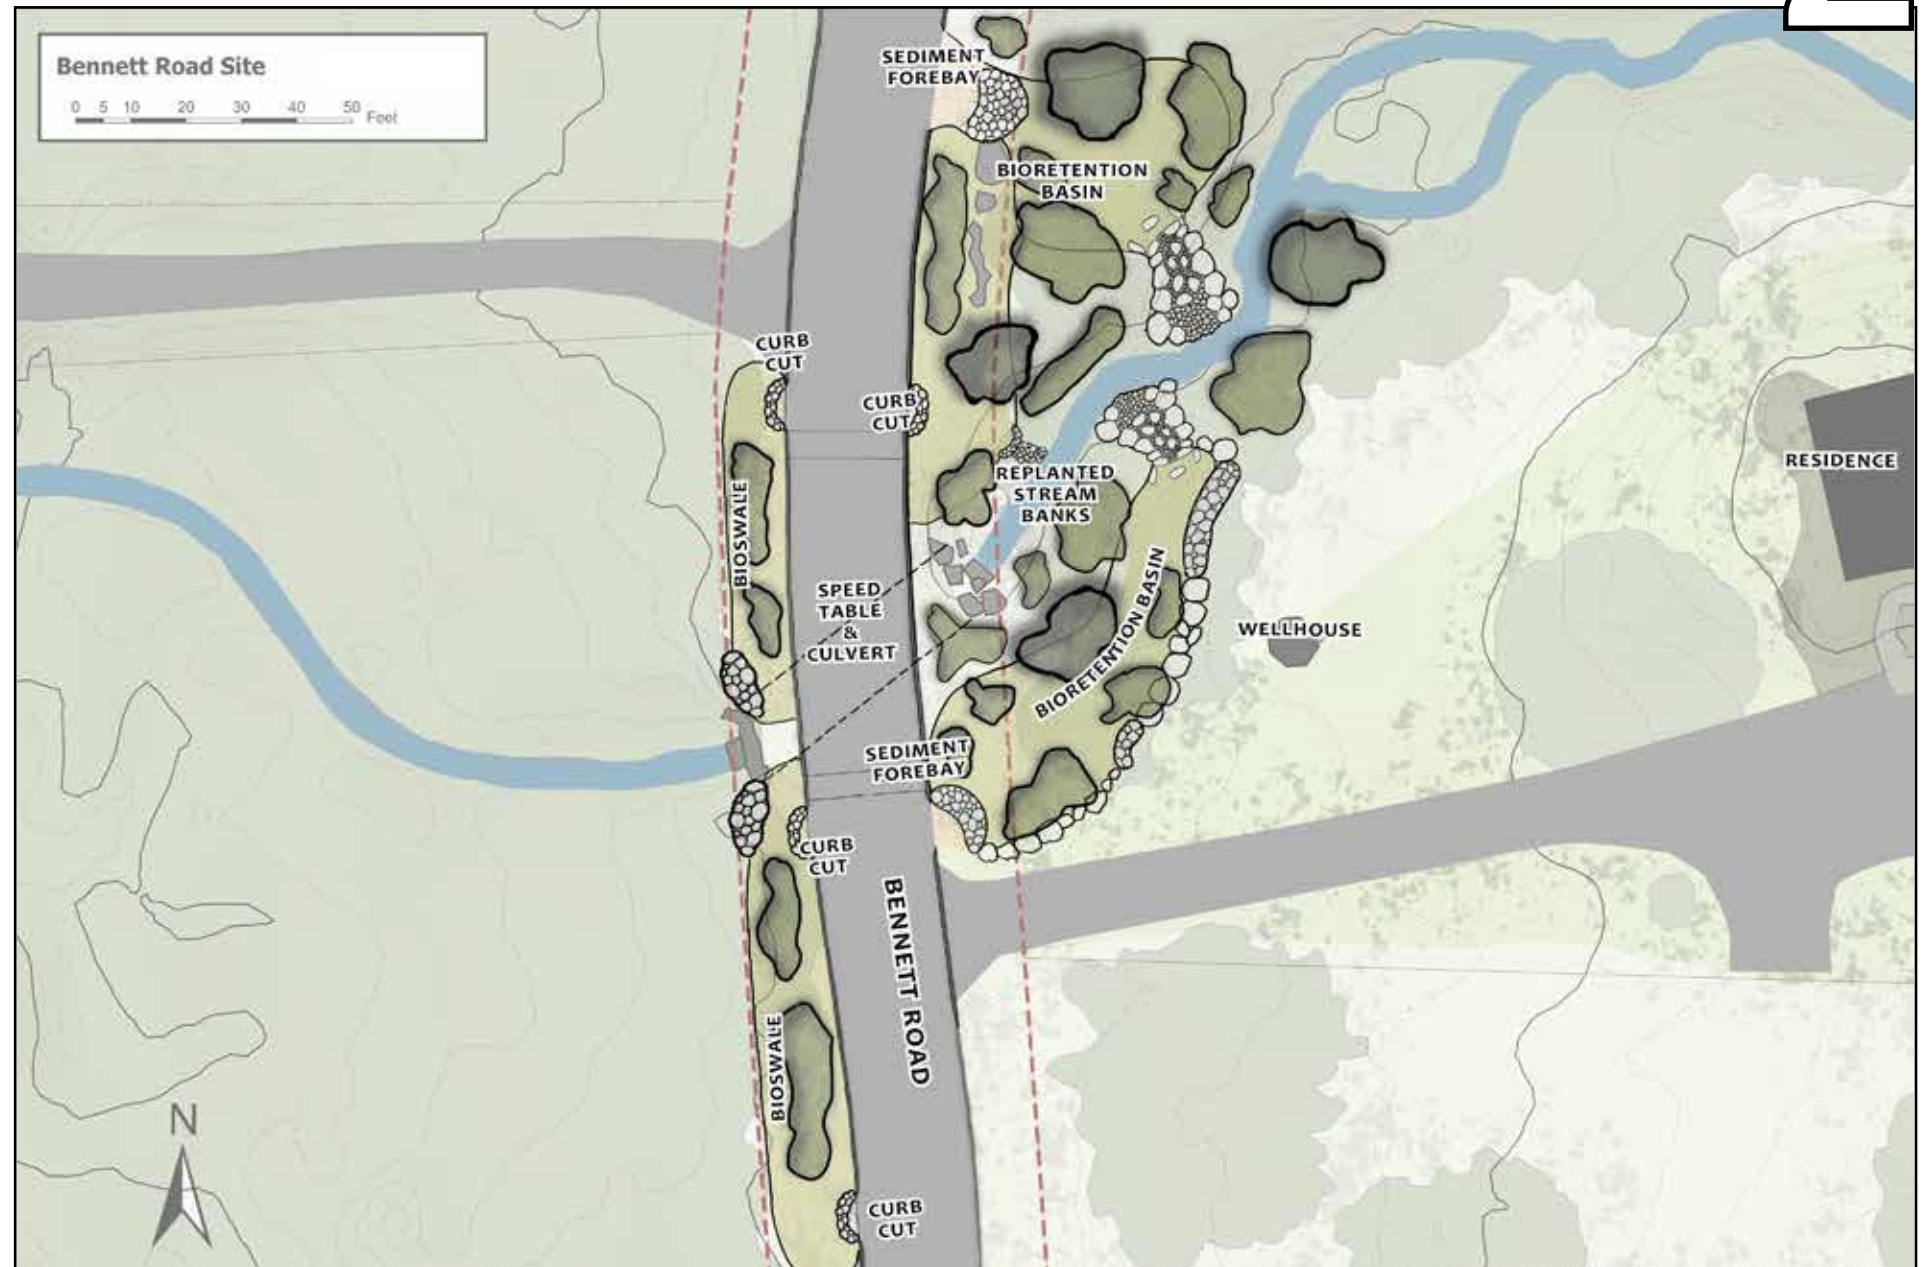
# Refined Design Alternative 2

## "A Boulder Approach"

*Extends beyond the ROW as part of a cooperative verbal agreement with the abutter to incorporate their property into the design. Anticipating increased storm intensities, the culvert is replaced and enlarged, allowing more stream flow during larger storm events. A raised speed table over the culvert slows down traffic on the road while also directing road runoff into the designed landscape.*

(5) On the west side of the road a simple bioswale directs water via curb cuts into a vegetated bioswale within the ROW, similar to RDA 1 (see previous page).

The bioretention basins and swales are planted with a diverse array of native riparian and wetland plants that help filter the water and provide crucial wildlife habitat and beauty to these systems. These plants are also used extensively around the basins along the stream bank, mitigating erosion. Ongoing relationship building, outreach and cooperation will need to be conducted with the abutter to maintain the stream bank native vegetation buffer beyond the basins themselves.

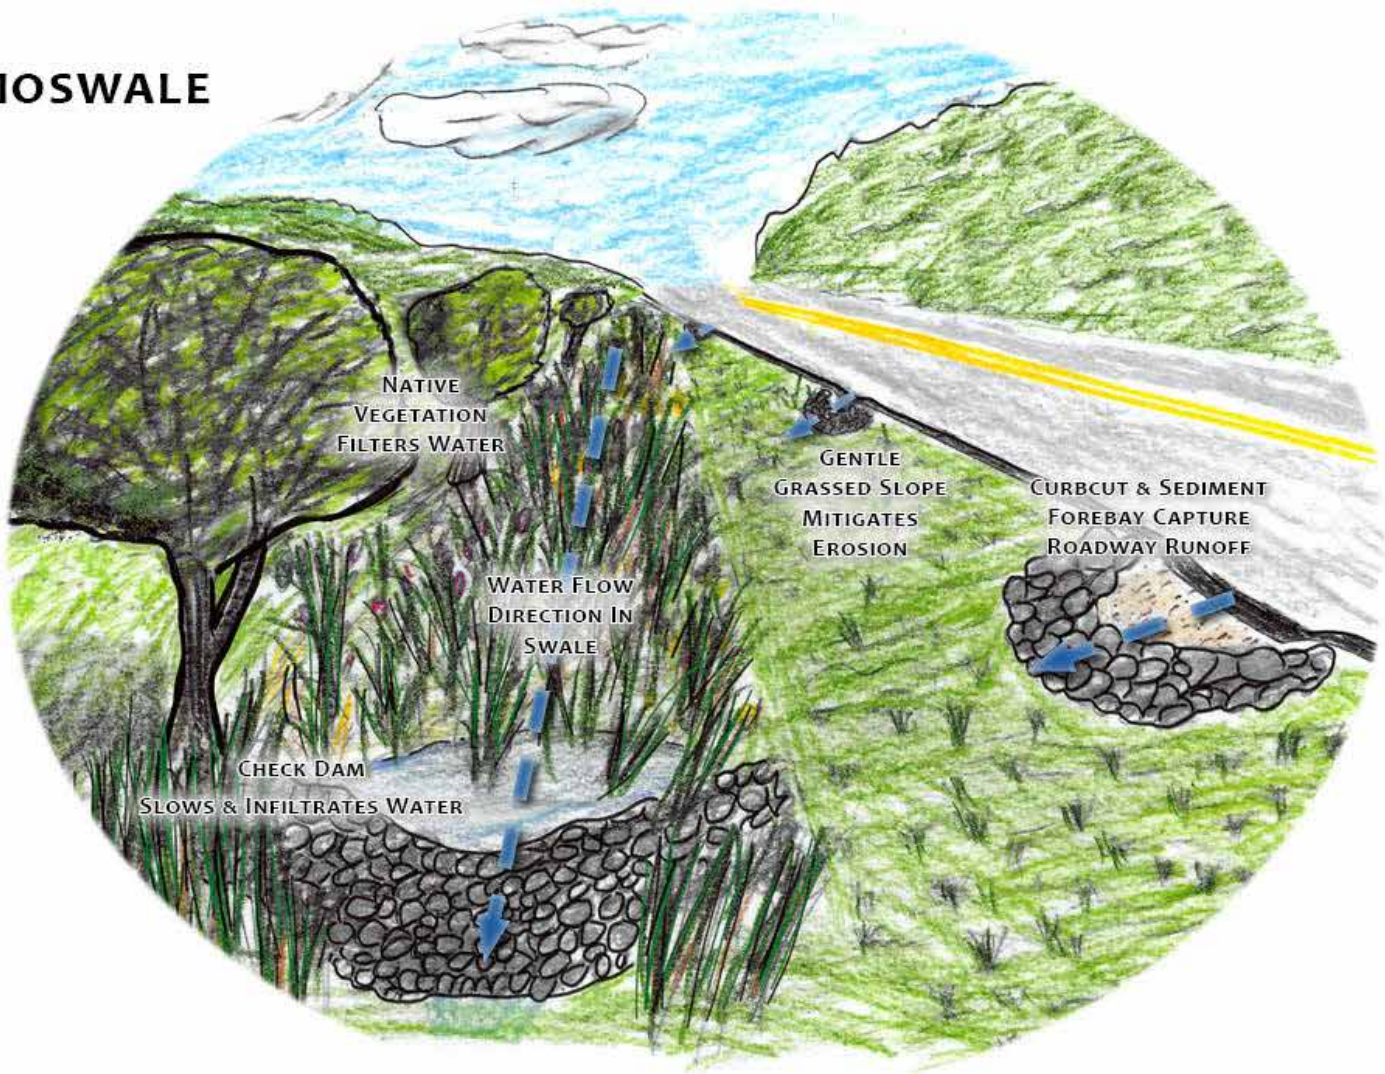
BIOSWALE

A bioswale (grass swale or water quality swale) is a combination treatment and conveyance BMP. As opposed to a general drainage swale which acts solely as conveyance, a Bioswale conveys water along a vegetated open channel while also slowing, filtering and infiltrating water. It may include a series of cells within the channel formed by check dams or berms which further slow the water flow, increasing sediment dropout and infiltration. Bioswales may collect

water runoff from a pipe, directly from a roadway, or be connected to other BMP's as part of a complete stormwater system. Roadside bioswales provide water quality and quantity control benefits, while reducing driving hazards by keeping stormwater flows away from street surfaces and can be used to retrofit existing drainage channels and grass channels. Pollutant removal in these swales relies on sedimentation, adsorption and microbial breakdown.

*Pollutant Removal:* Achieves 70% TSS removal when provided with a pretreatment device such as a sediment forebay with a check dam.

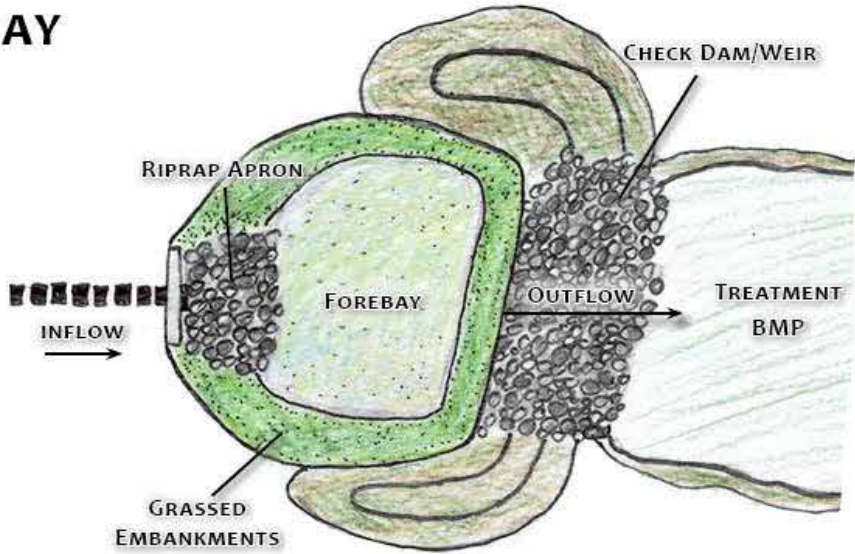
PLAN VIEW

**Pollutant Removal:** MassDEP requires a sediment forebay as pretreatment before stormwater is discharged into infiltration basins. They can remove coarse sediment fractions but not soluble pollutants.

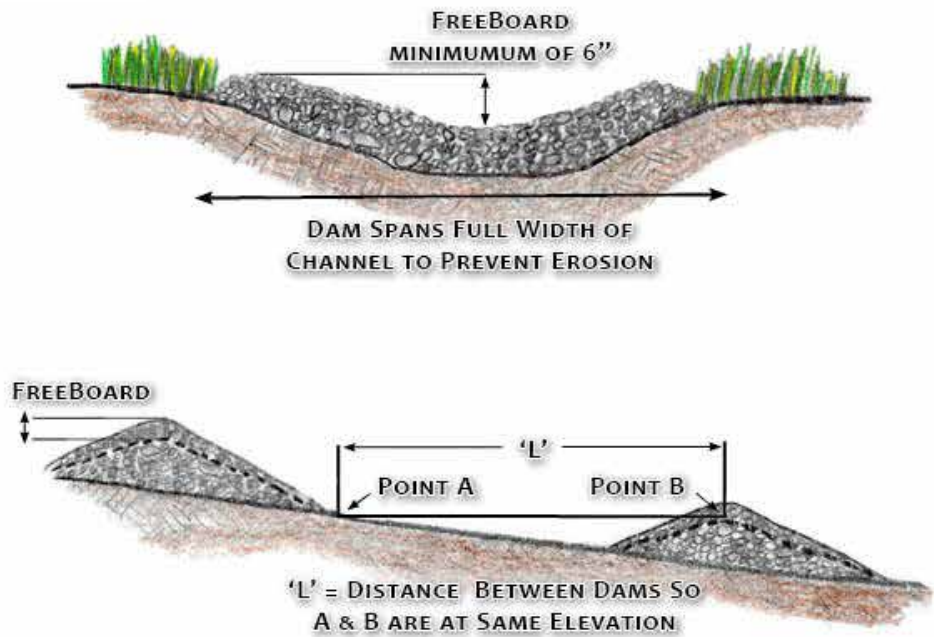
## CHECK DAMS

A check dam or leaky weir is a small dam constructed across a drainage ditch, swale or channel to lower the velocity of flow. They cause water to pond in small pools, and then slowly seep through the dam or infiltrate into the soil. They dissipate the energy of flow, allow suspended sediment particles to settle

out, promote infiltration and enhance water quality treatment volume. They can be a simple way to reduce downstream flood peak flow by temporarily storing water and are relatively easy and inexpensive to construct.

**Usage:** Can be used in small open channels that drain 10 acres or less or channels where stormwater velocities exceed 5 feet per second. They should not be used in live stream channels.

**Maintenance:** Inspect check dams after every significant rainfall event. Repair damage as needed. Remove sediment as needed.
